PERATION

GREENHOUSE

SCIENTIFIC DIRECTOR'S REPORT

ANNEX 3.2 U. S. NAVY STRUCTURES

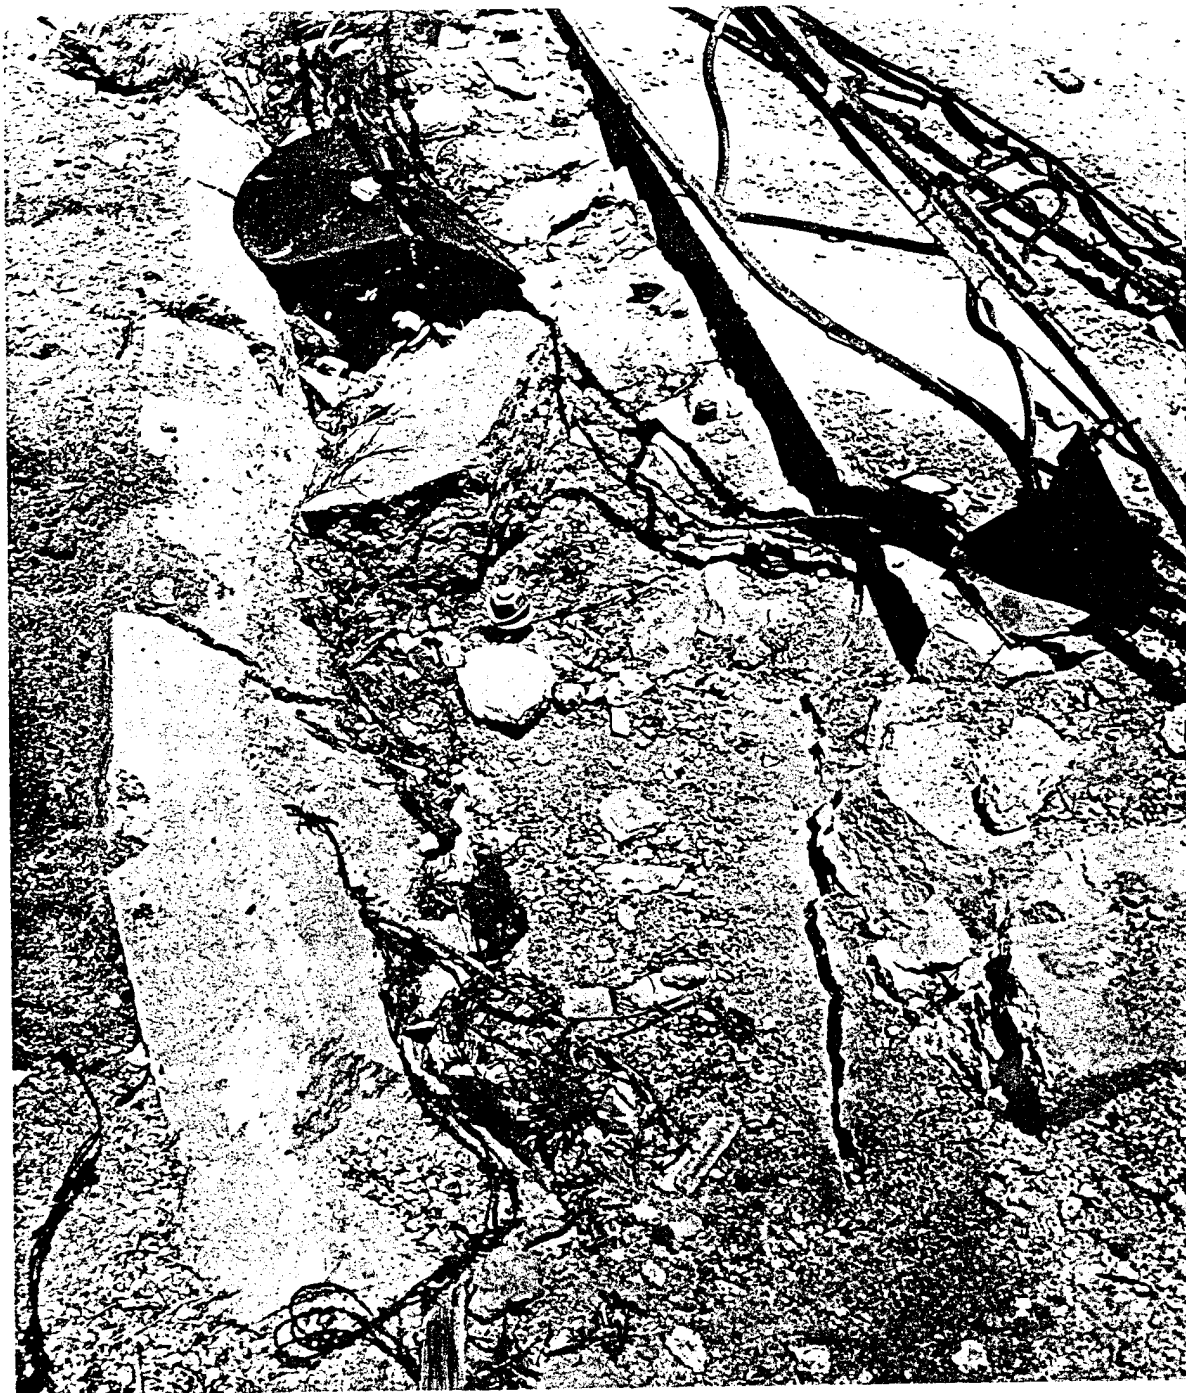
Fig. L.157 Detail View along Left Edge of Foundation, Structure 3.2.3a. Heavy foundation crack developed when left end wall was forced outward. Outer lip of foundation was broken loose by the same action.

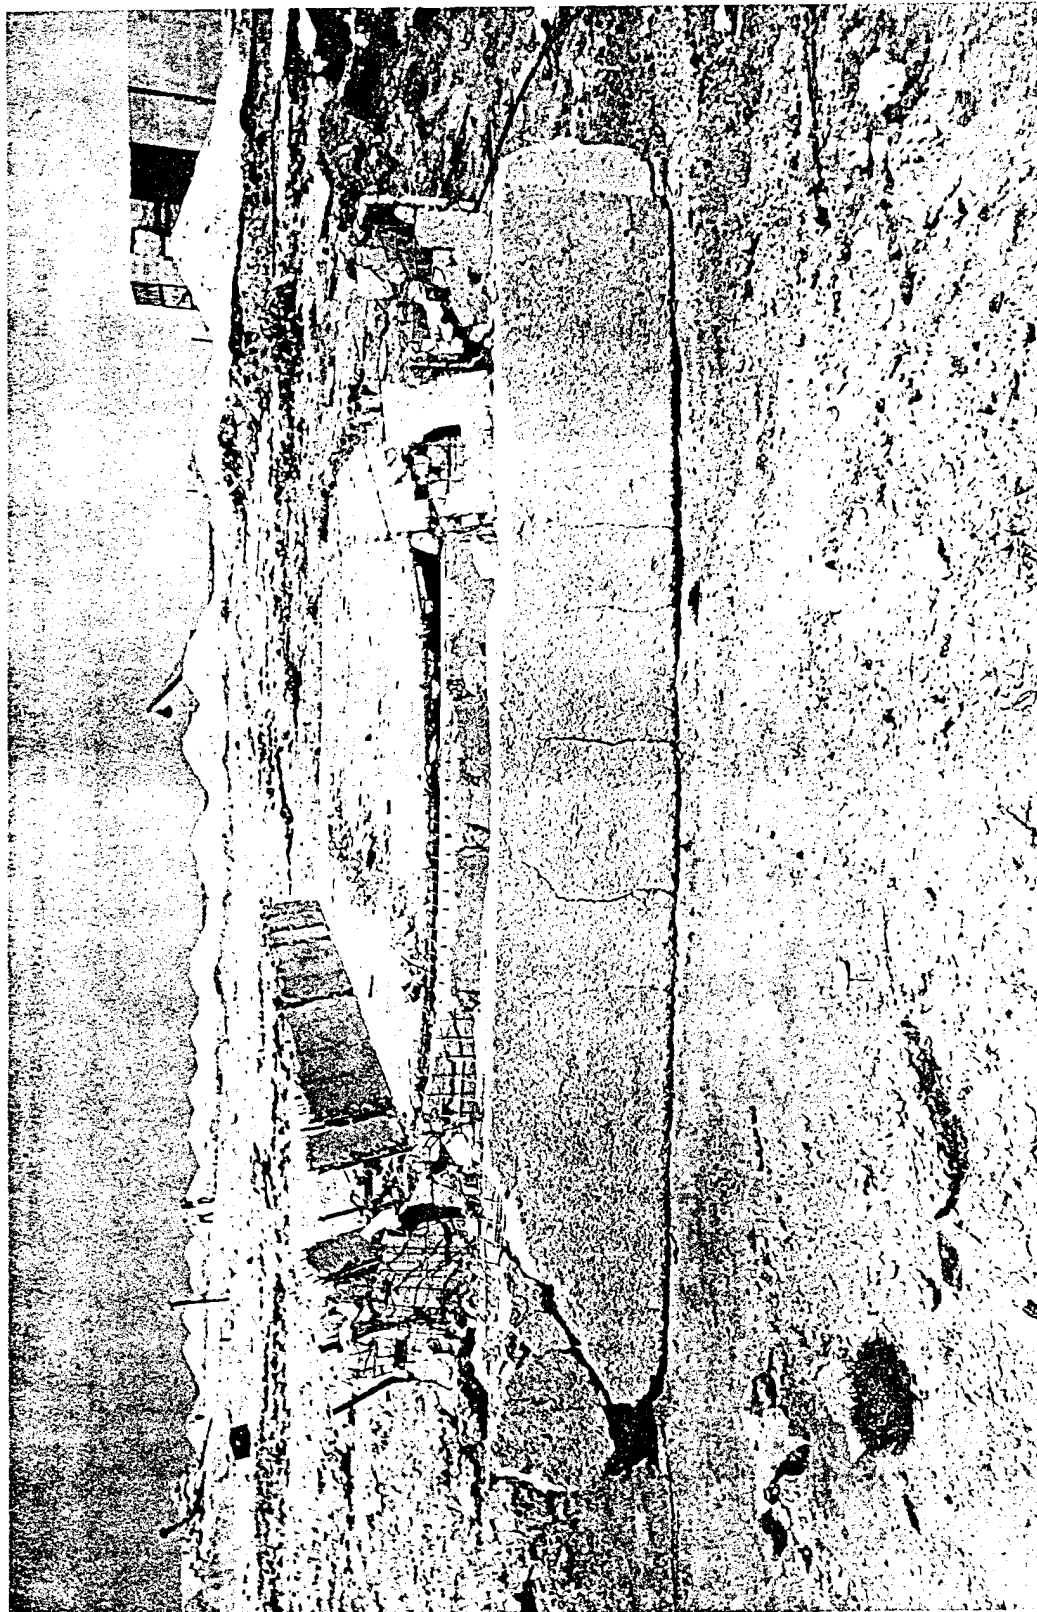
Fig. L.165 Front Edge of Left End Wall, Structure 3.2.3a. Note concave curvature of wall panels and pilaster corner.

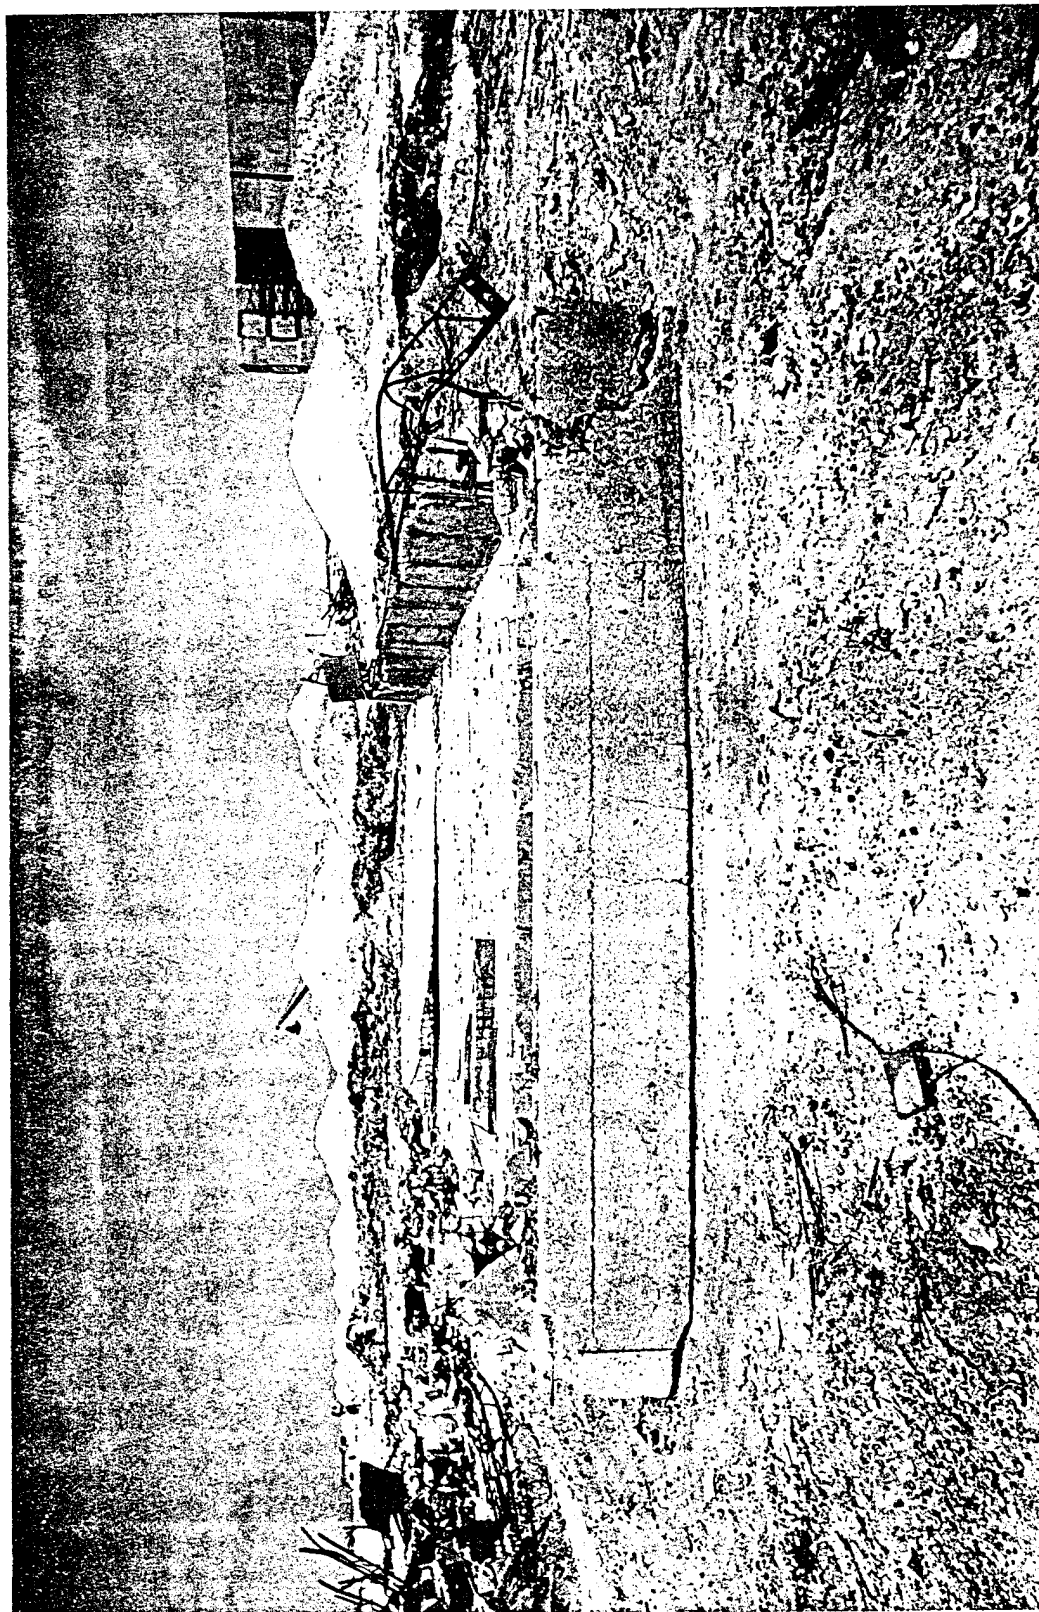
Fig. L.177 Front Edge of Right End Wall, Structure 3.2.3a. Note how edge row of roof cells remained with end wall. Internal truss can be seen distorted out of position by tearing action.

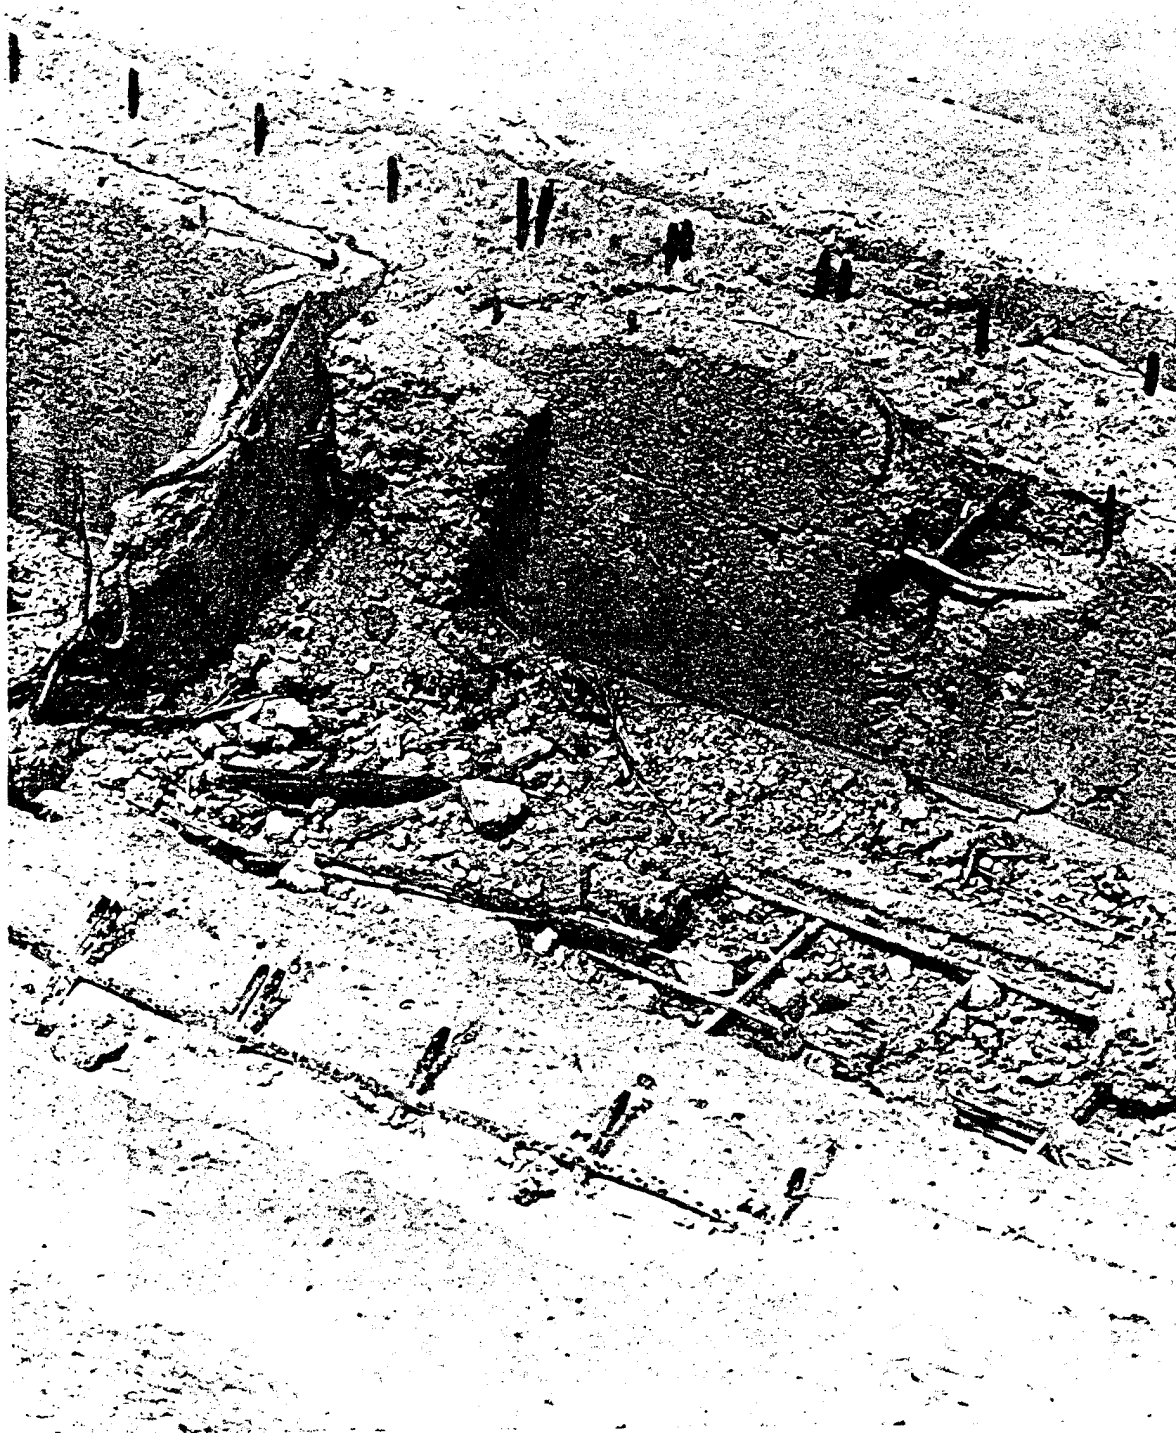
Fig. L.181 Detail View of Part of Cell from Rear-wall Panel Still Embedded in Corner Pilaster, Structure 3.2.3a

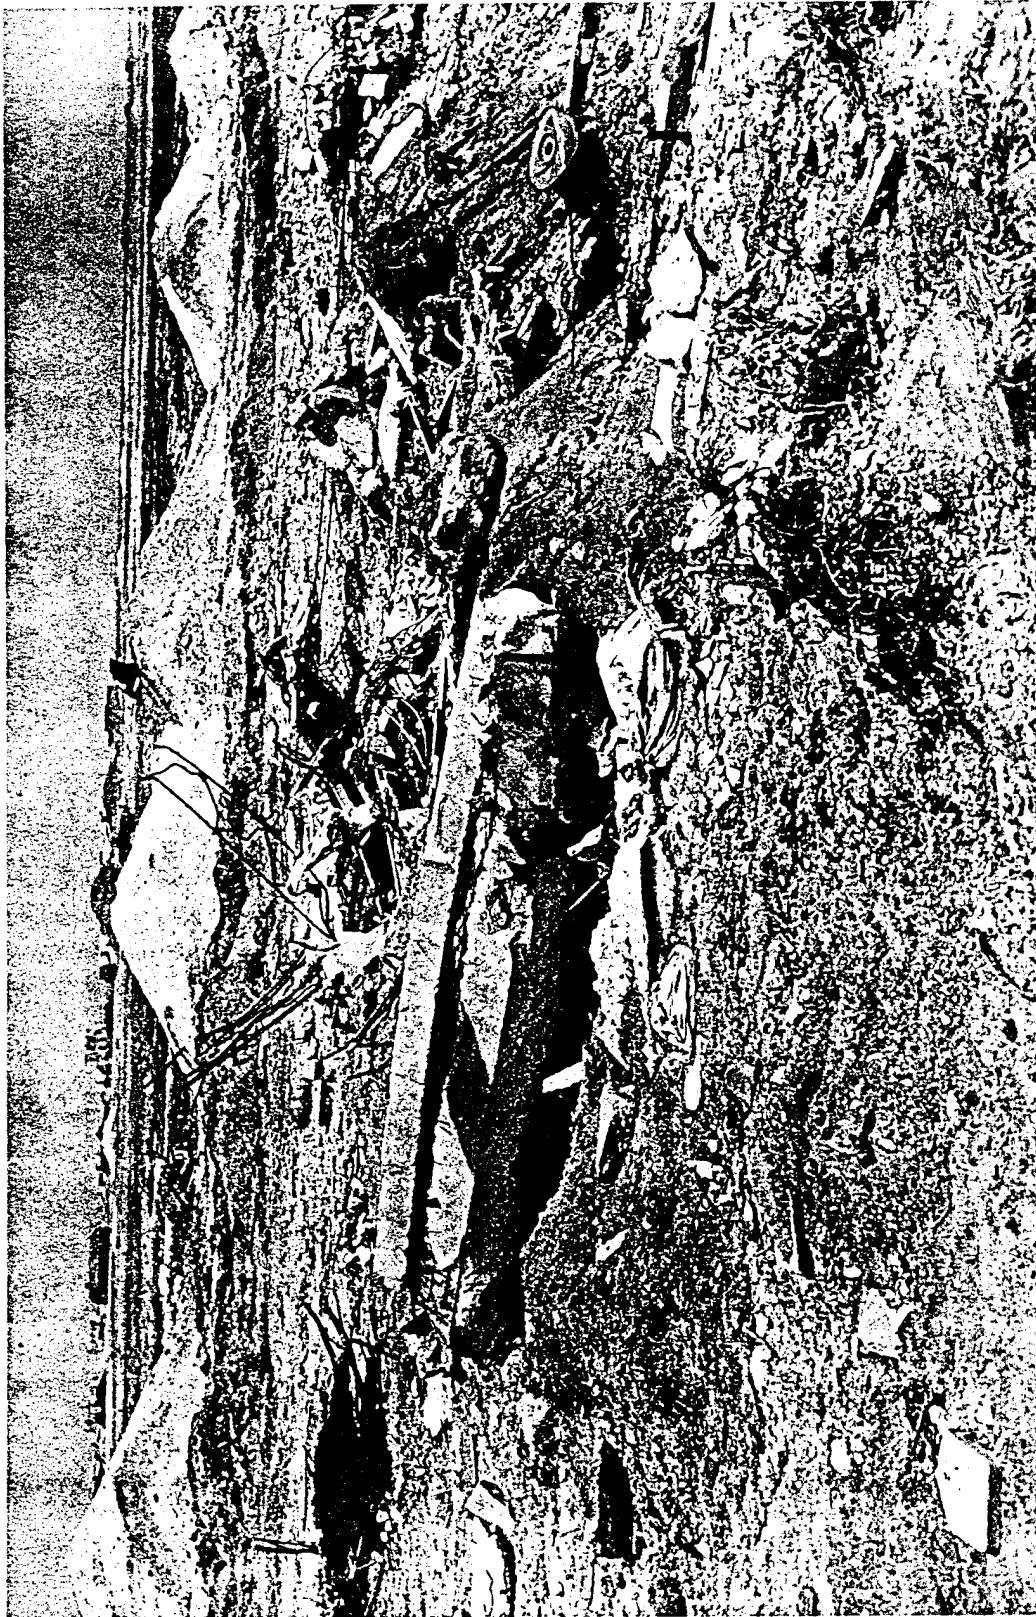
Fig. L.190 Left End of Rear Wall, Structure 3.2.3a. Plaster corner was severely damaged, and the two panels closest to the left edge were heavily damaged. Earth was dumped later by a shovel operating in the vicinity.

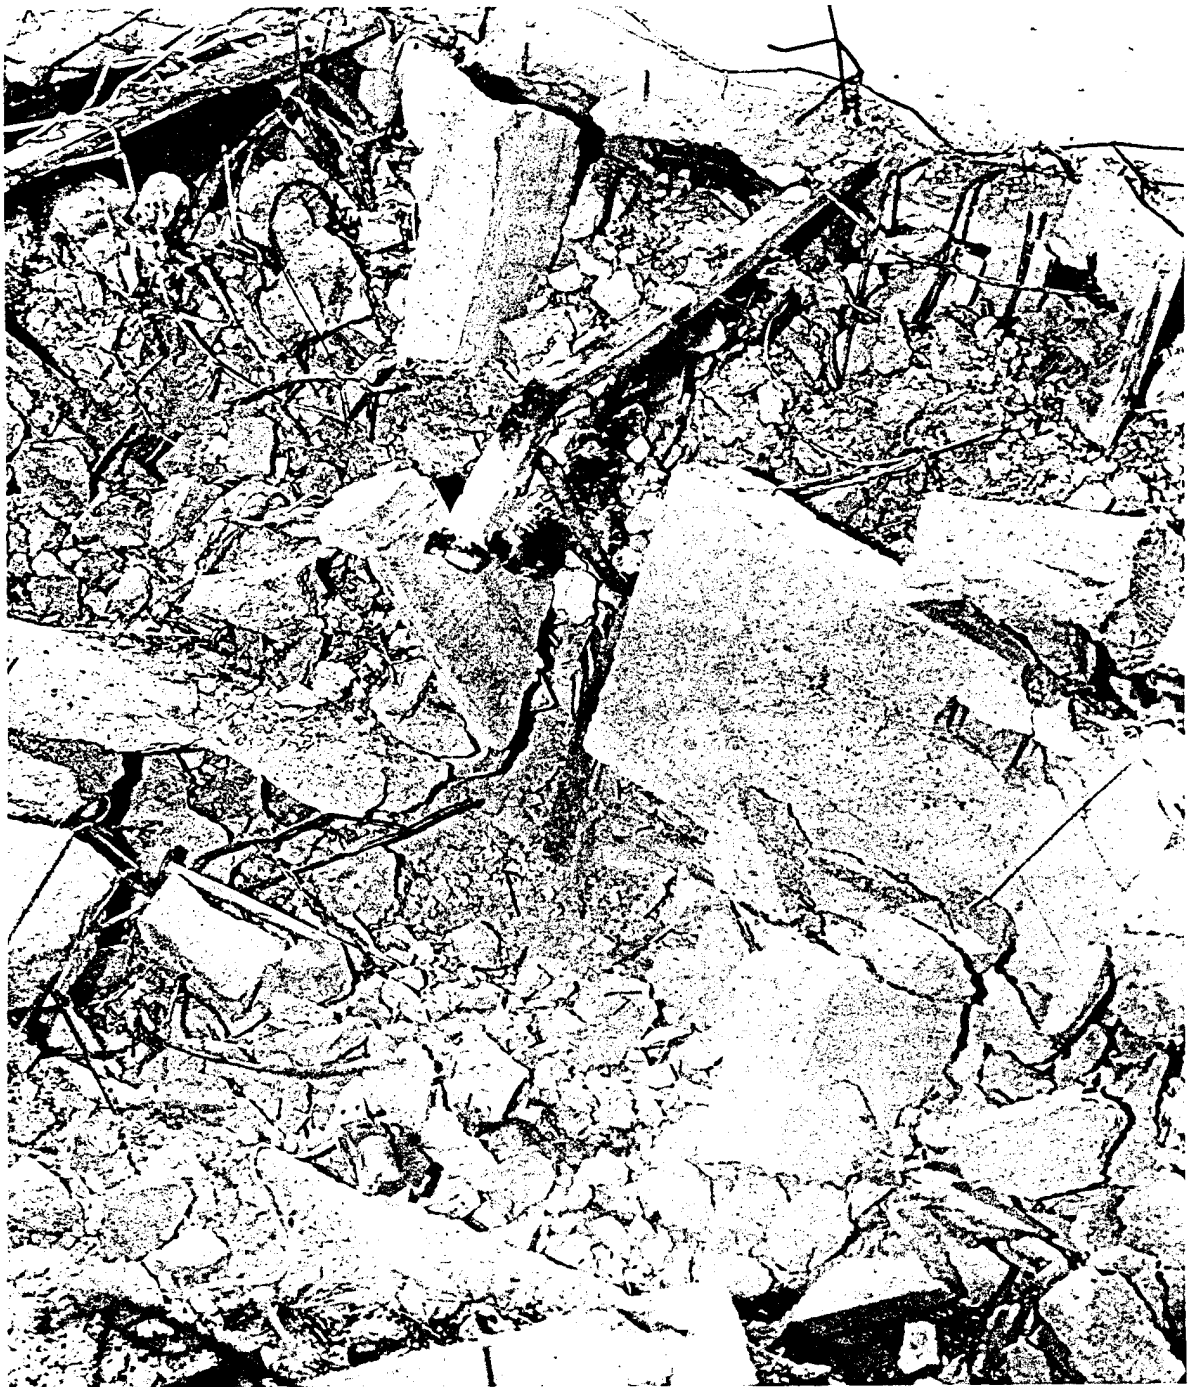
Fig. L.193 Detail View of Rear-wall Truss, with One Chord Ruptured from Anchorage Channel but Other Chord Still Attached to Foundation, Structure 3.2.3a. Note severe bend in lower end of truss.

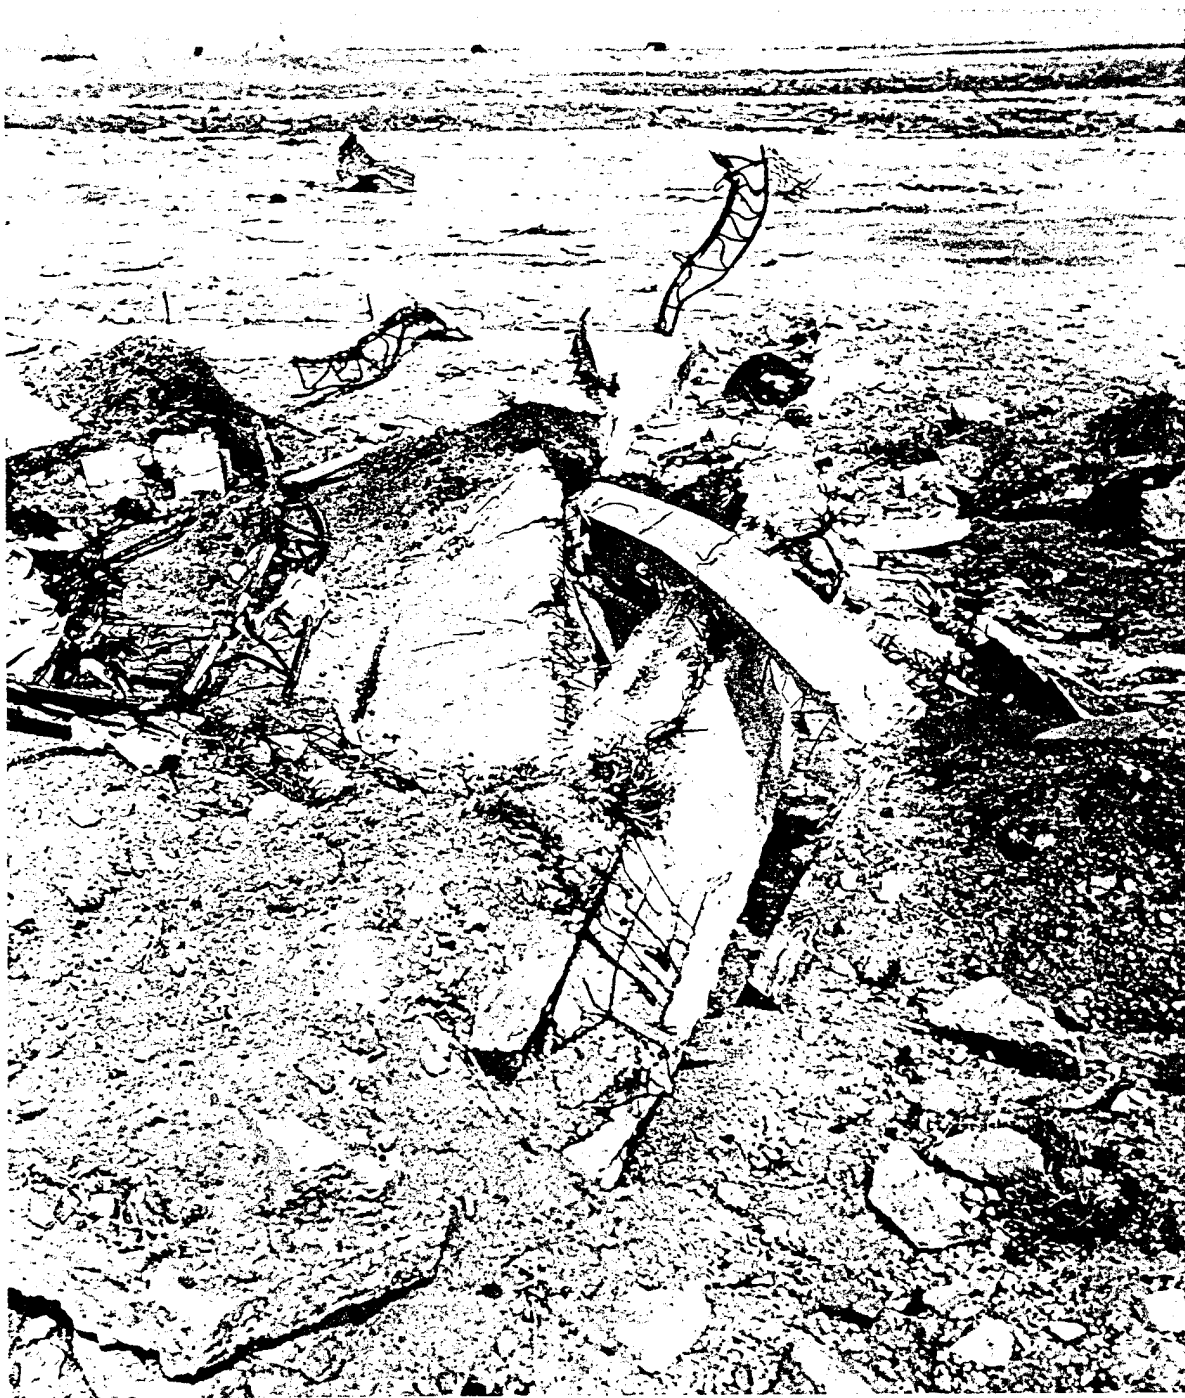
Fig. L.194 Destroyed Corner Pilaster and Adjacent Panel at Left Rear Corner of Structure, 3.2.3a

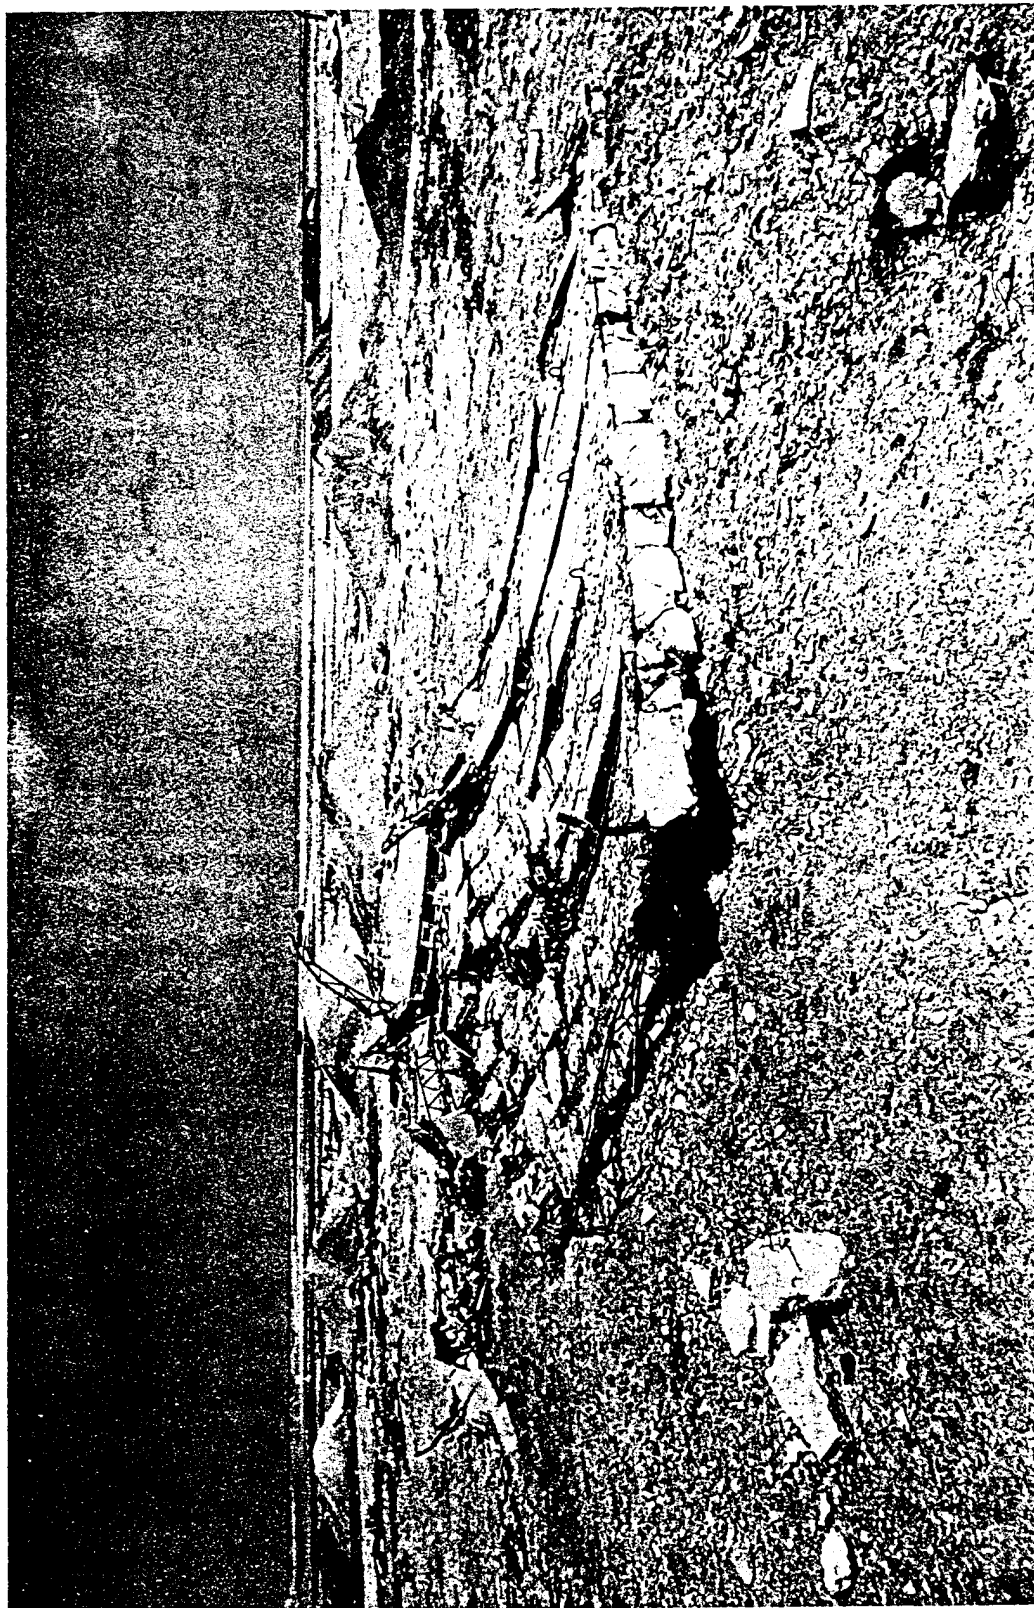
Fig. L.199 Right Half of Roof, with Front Edge in Foreground, Structure 3.2.3a. This section has its underside up. Rear edge struck ground first, dug in, and then entire section flipped over, causing extensive damage to panels.

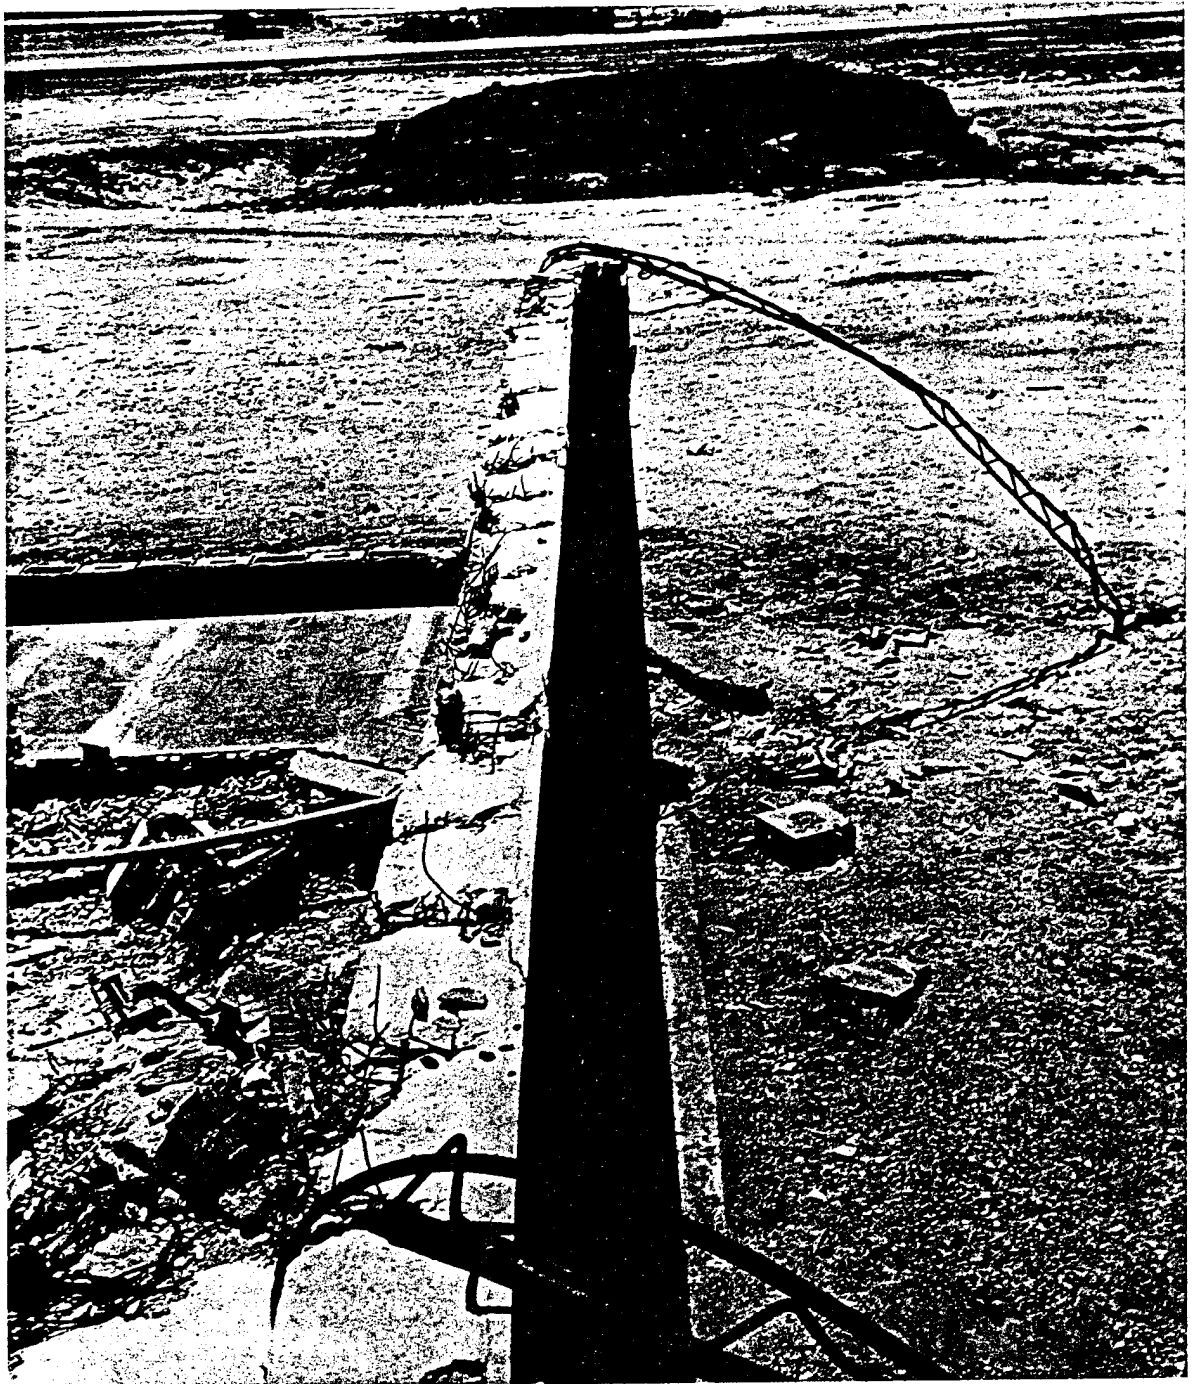
Fig. L.233 View along Top of Rear Wall, Structure 3.2.3b. Little damage was done to the top surface. Extreme bending of roof trusses as roof flipped over can be seen.

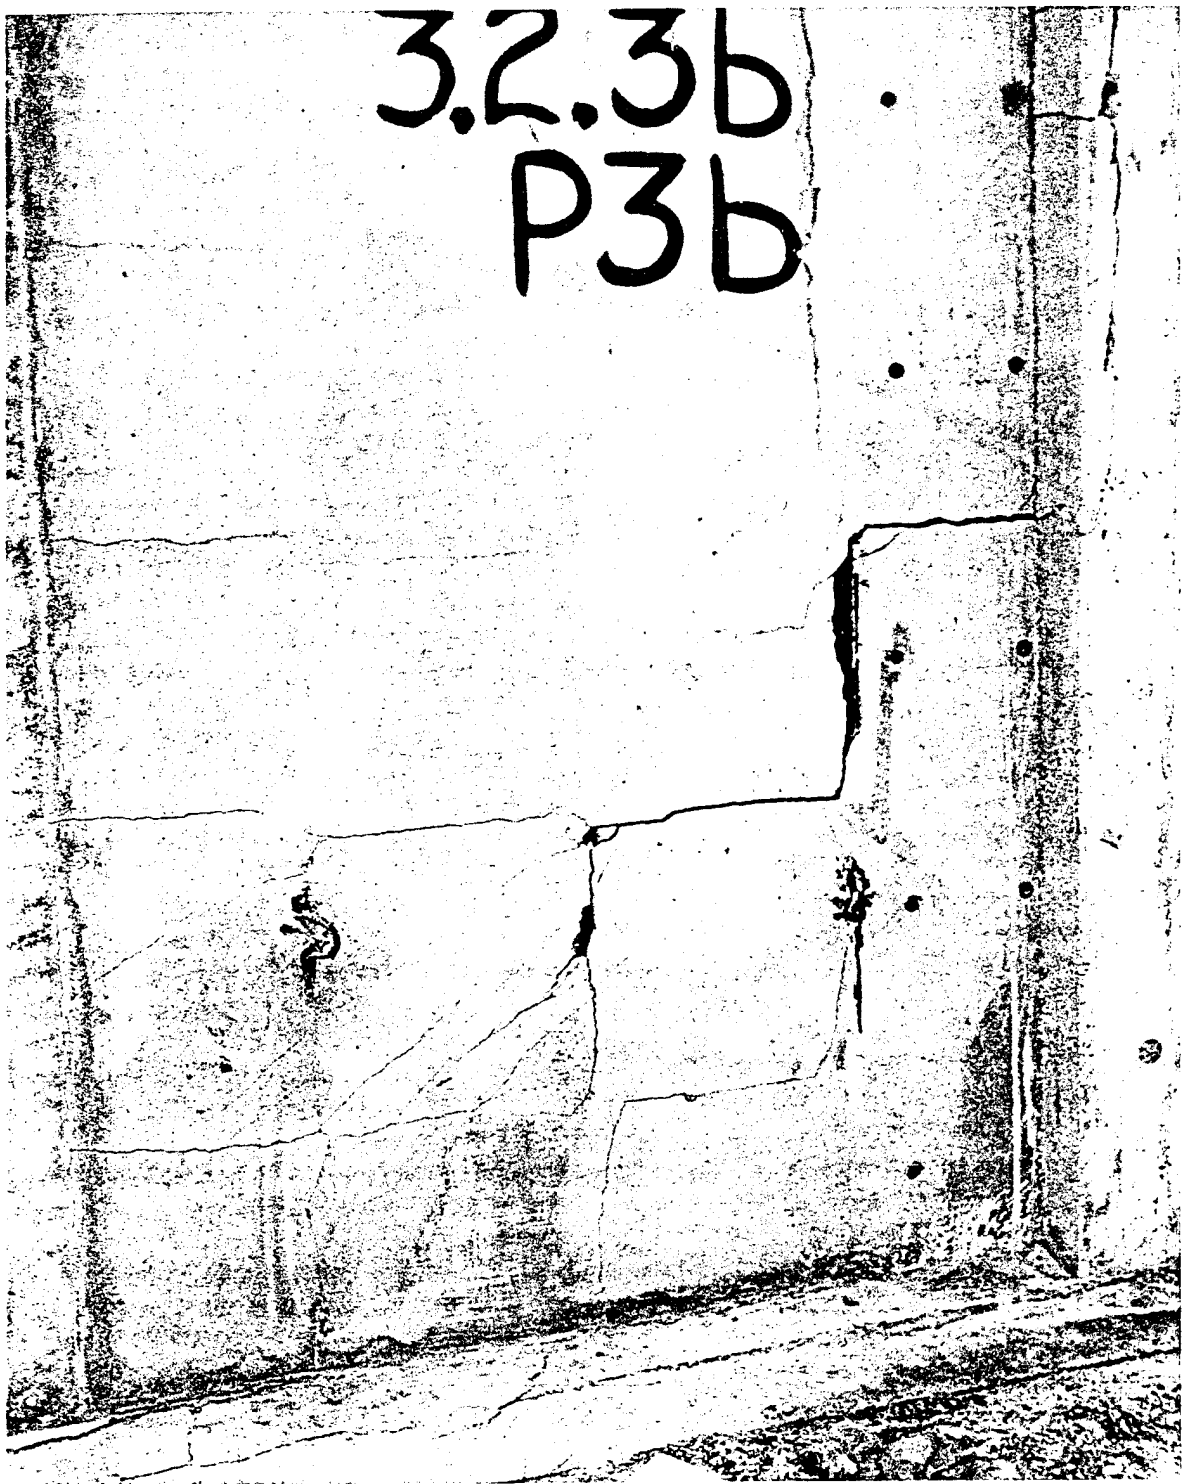
Fig. L.243 Detail View of Cracks in Rear-wall Panel Adjacent to Pilaster, Structure 3.2.3b

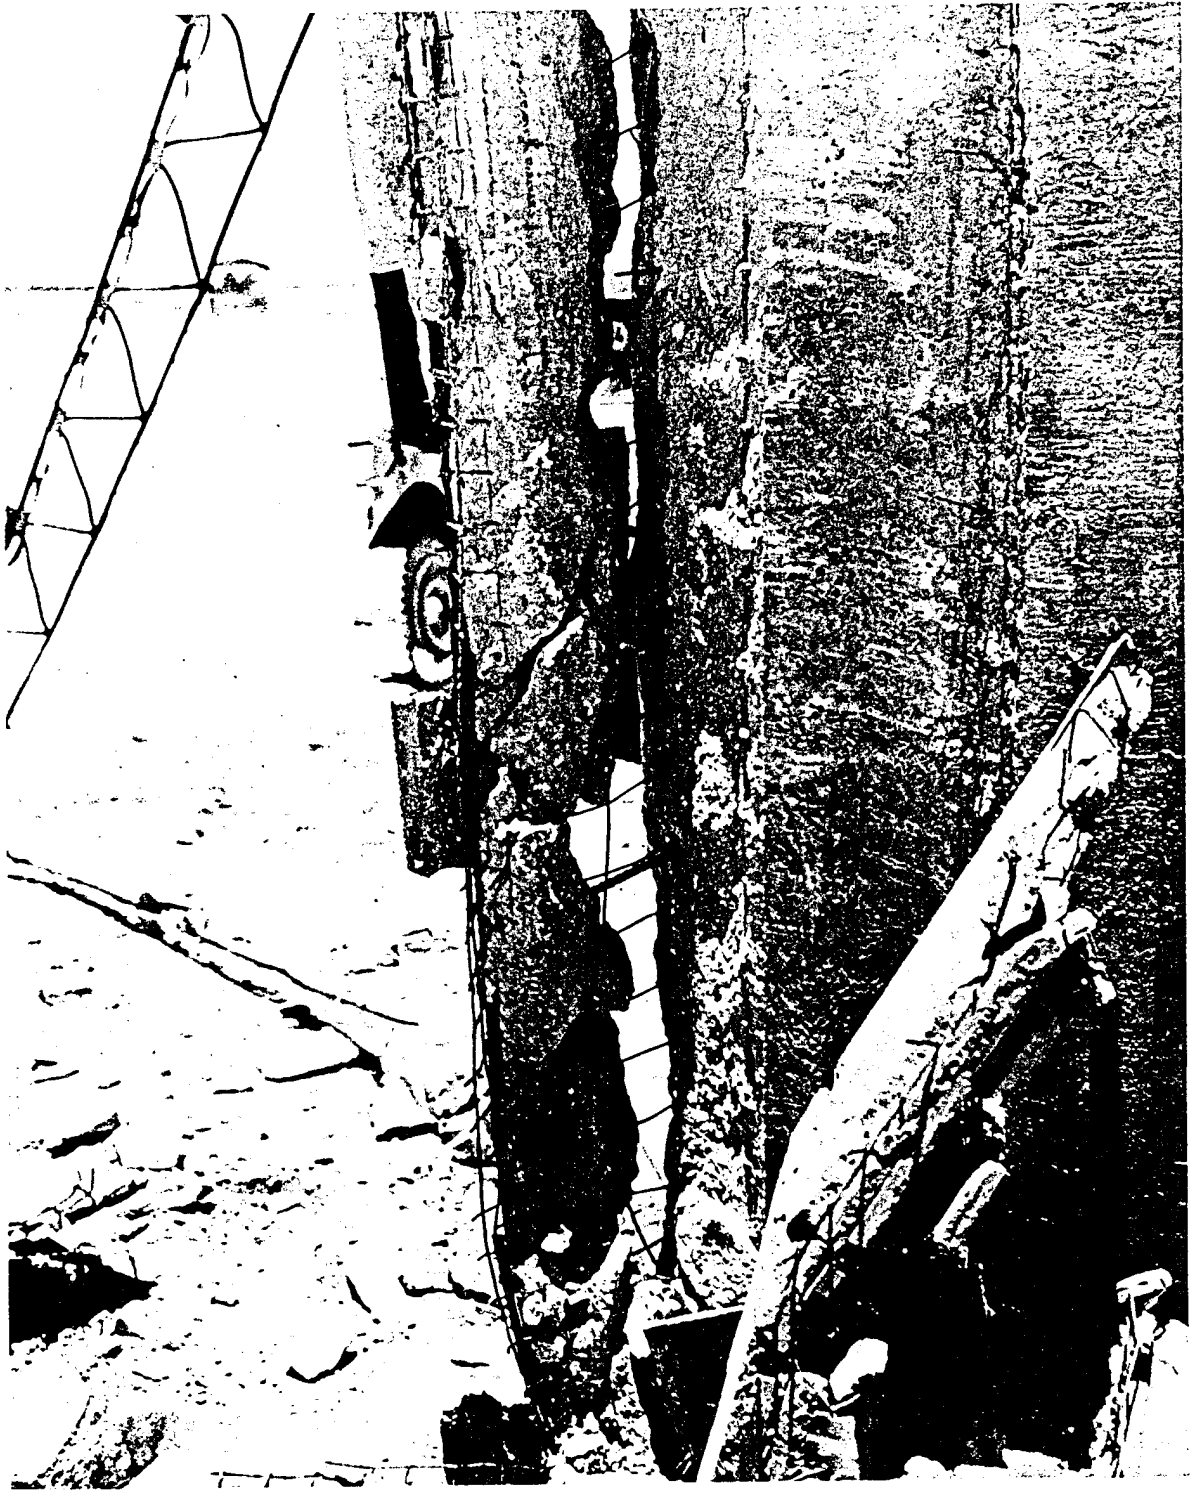
Fig. L. 245 Detail View of Pilaster at Left Rear Corner, Showing Where End Wall Forced Pilaster to Split Open, Structure 3.2.3b.

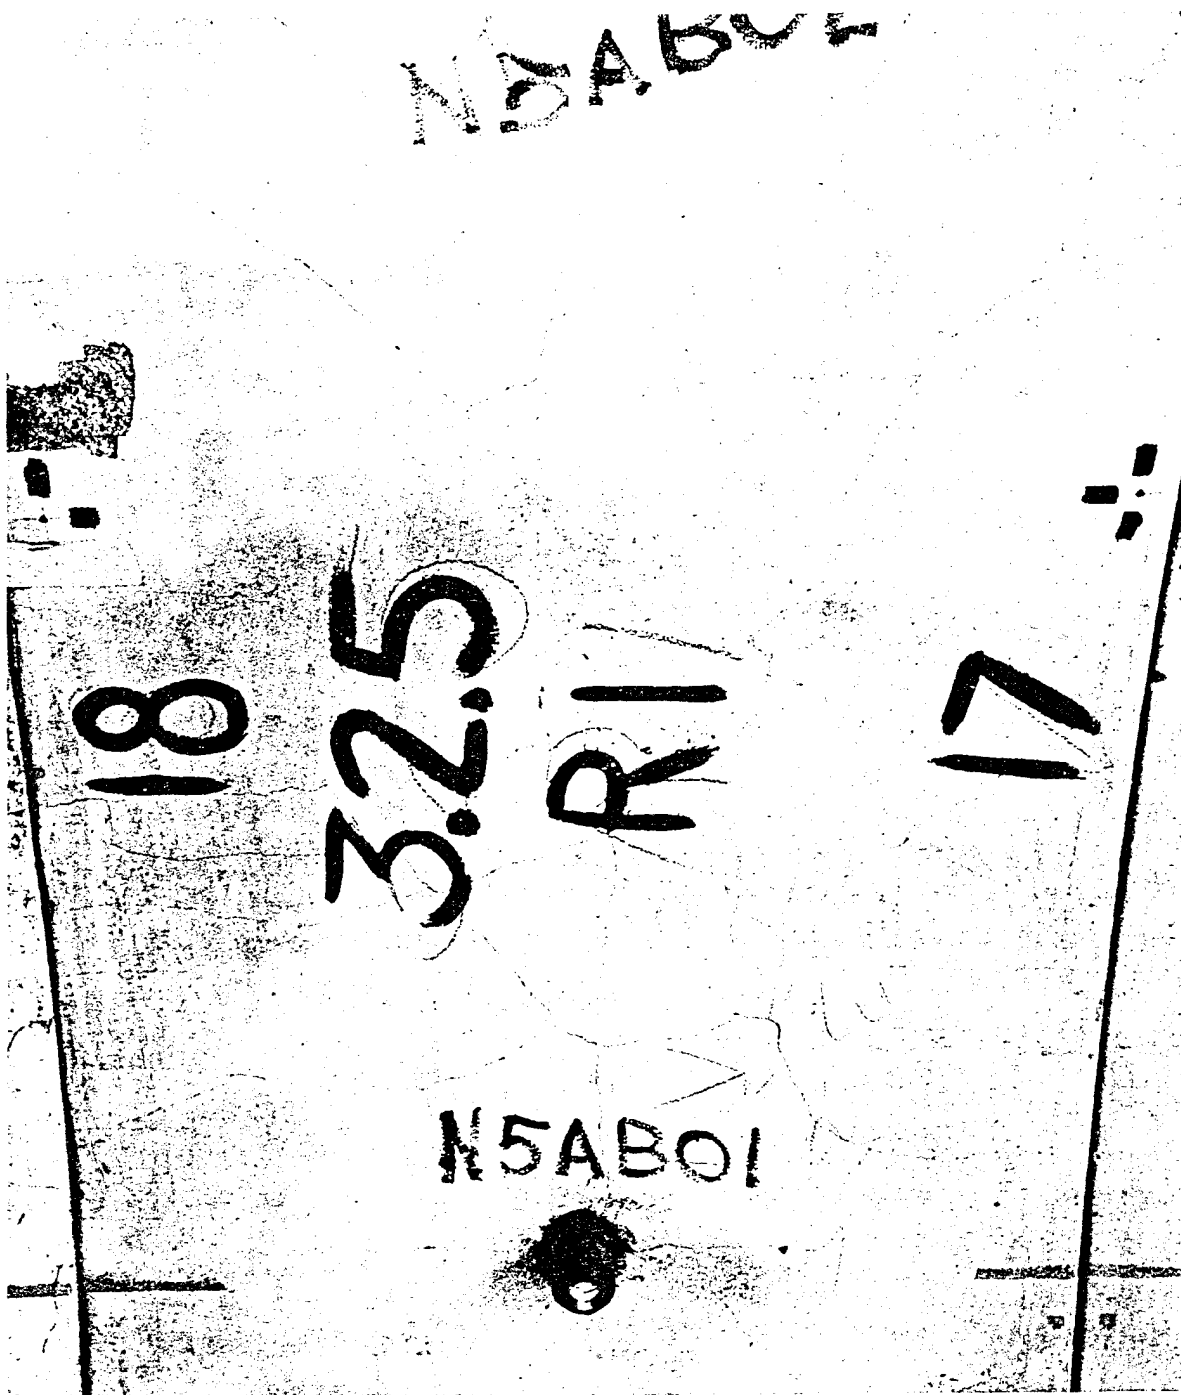
Fig. L. 414 Interior of Ribs-out Front Panel 17-18, Showing Cracking in Skin, Structure 3.2.5. This panel has extra cross ribs omitted.

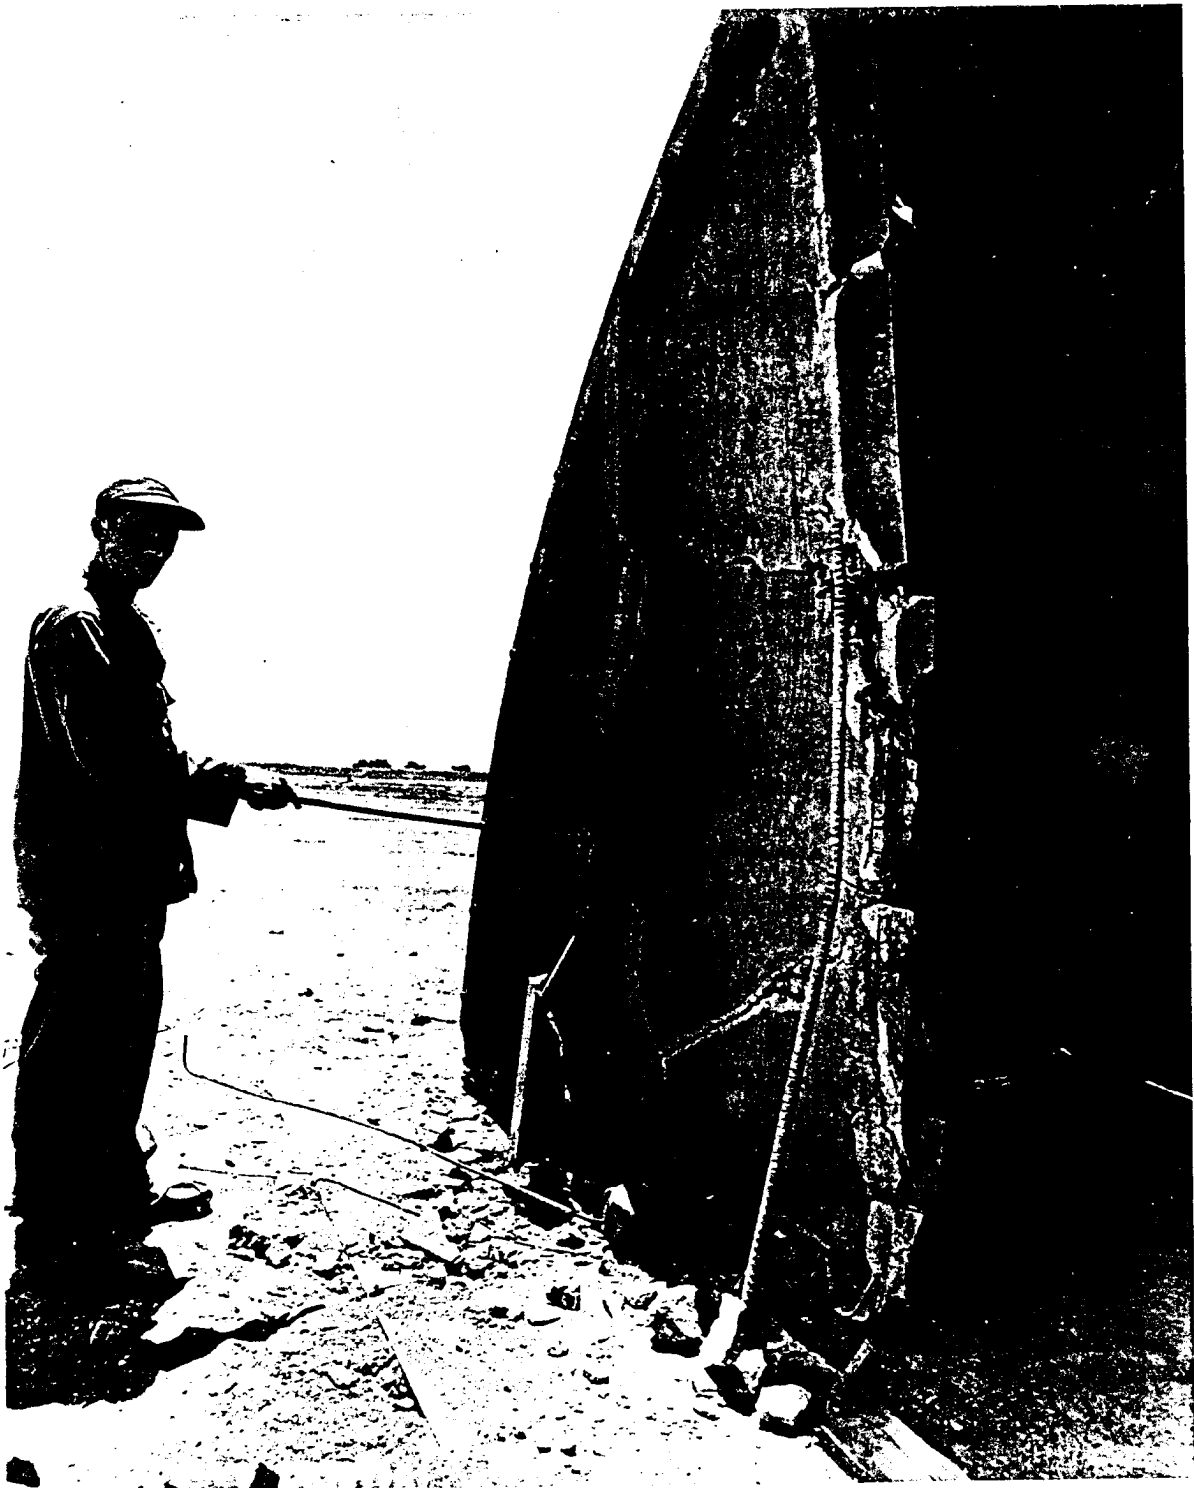
Fig. L.424 Front Panel on Right End Wall, Structure 3.2.5. Note separation of center rib from skin and failure of concrete around anchor bolts.
